Office of Child Support Services (OCSS) BUILDING fka: *Arkla Plaza Building*

Building Location: 400 East Markham Street Little Rock, Arkansas

Date of Site Visit: 9/07/06

Field Notes, Background & General Observations

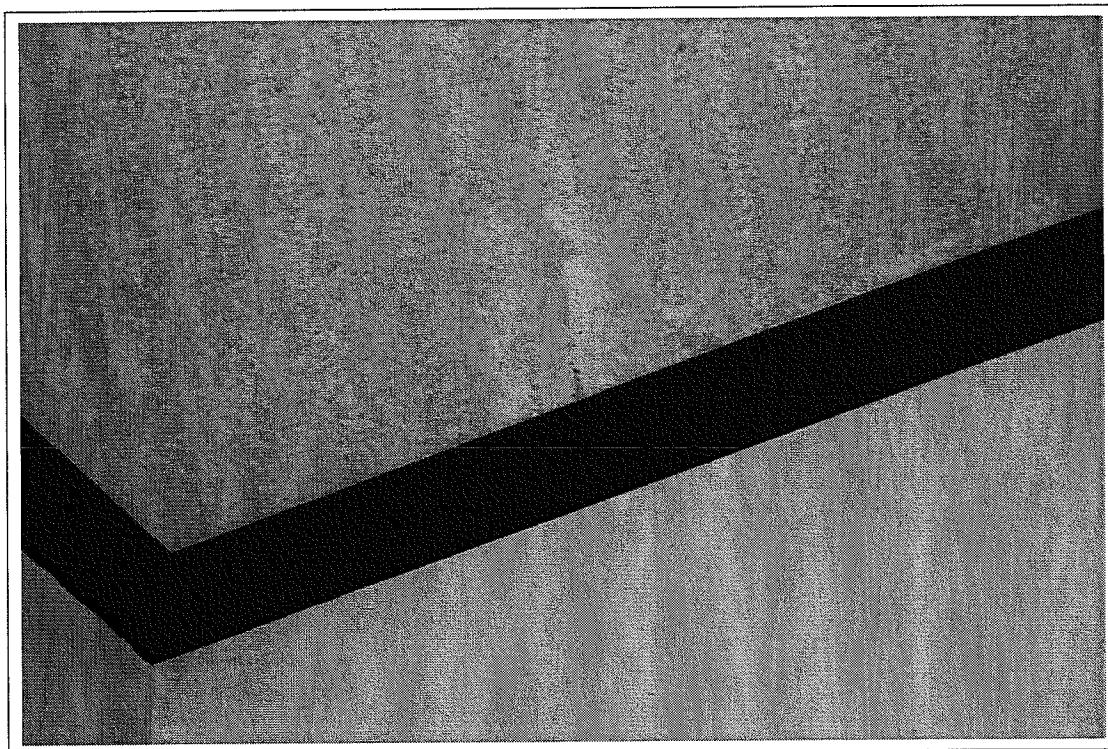
Photo 20. 1st floor west office areas - Damaged acoustical plaster in lobby

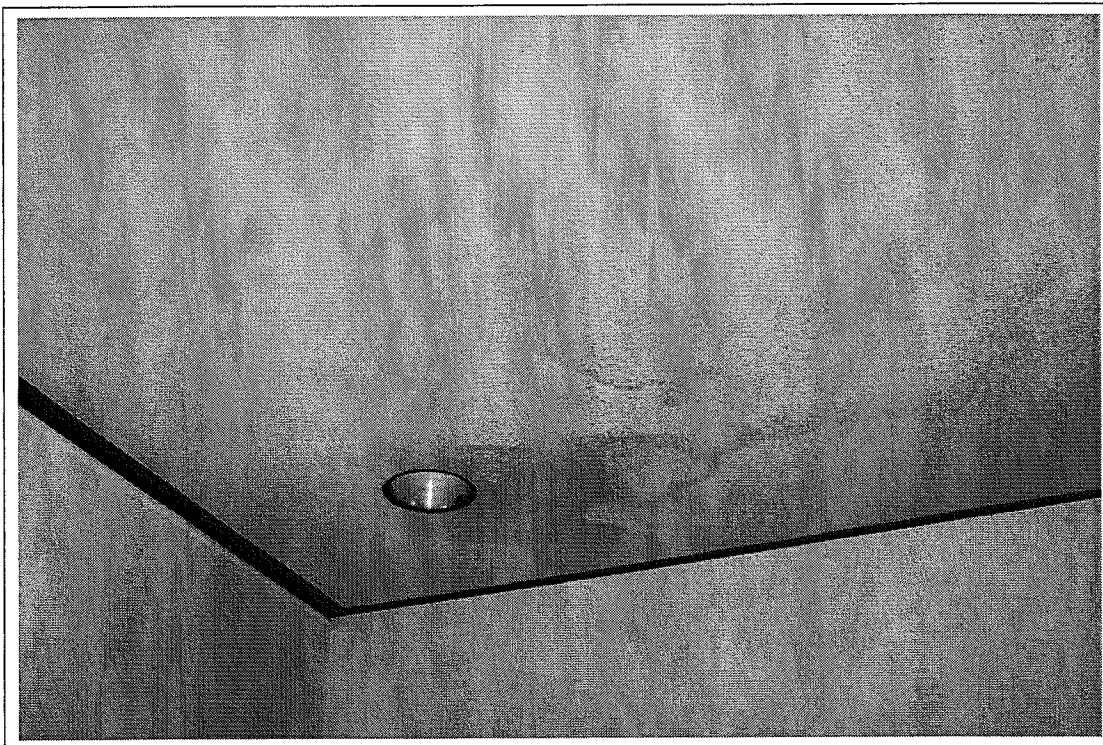
Photo 21. 1st floor west office areas - General view of water damaged acoustical plaster next to light

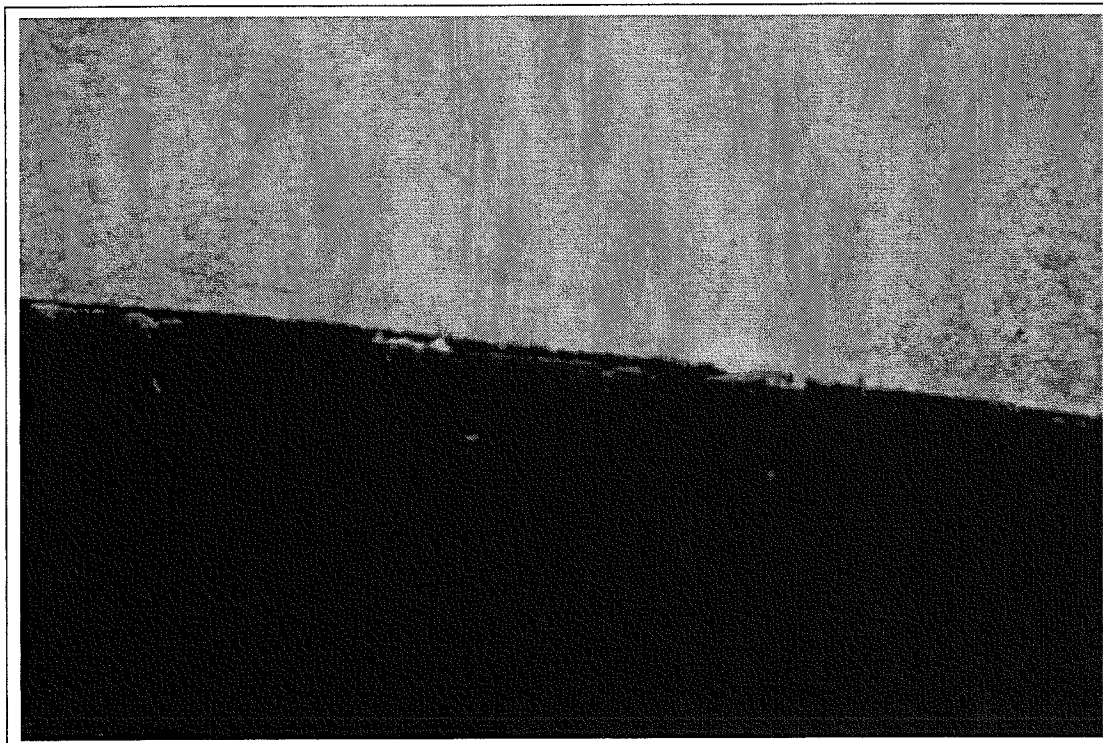
Photo 22. 1st floor auditorium - Close-up of impact damaged acoustical plaster in hallway outside auditorium
